**COUNTRY CLUB SUBDIVISION (PWS #3140021)
SOURCE WATER ASSESSMENT FINAL REPORT**

SOURCE WATER ASSESSMENT FOR COUNTRY CLUB SUBDIVISION, CALDWELL, IDAHO

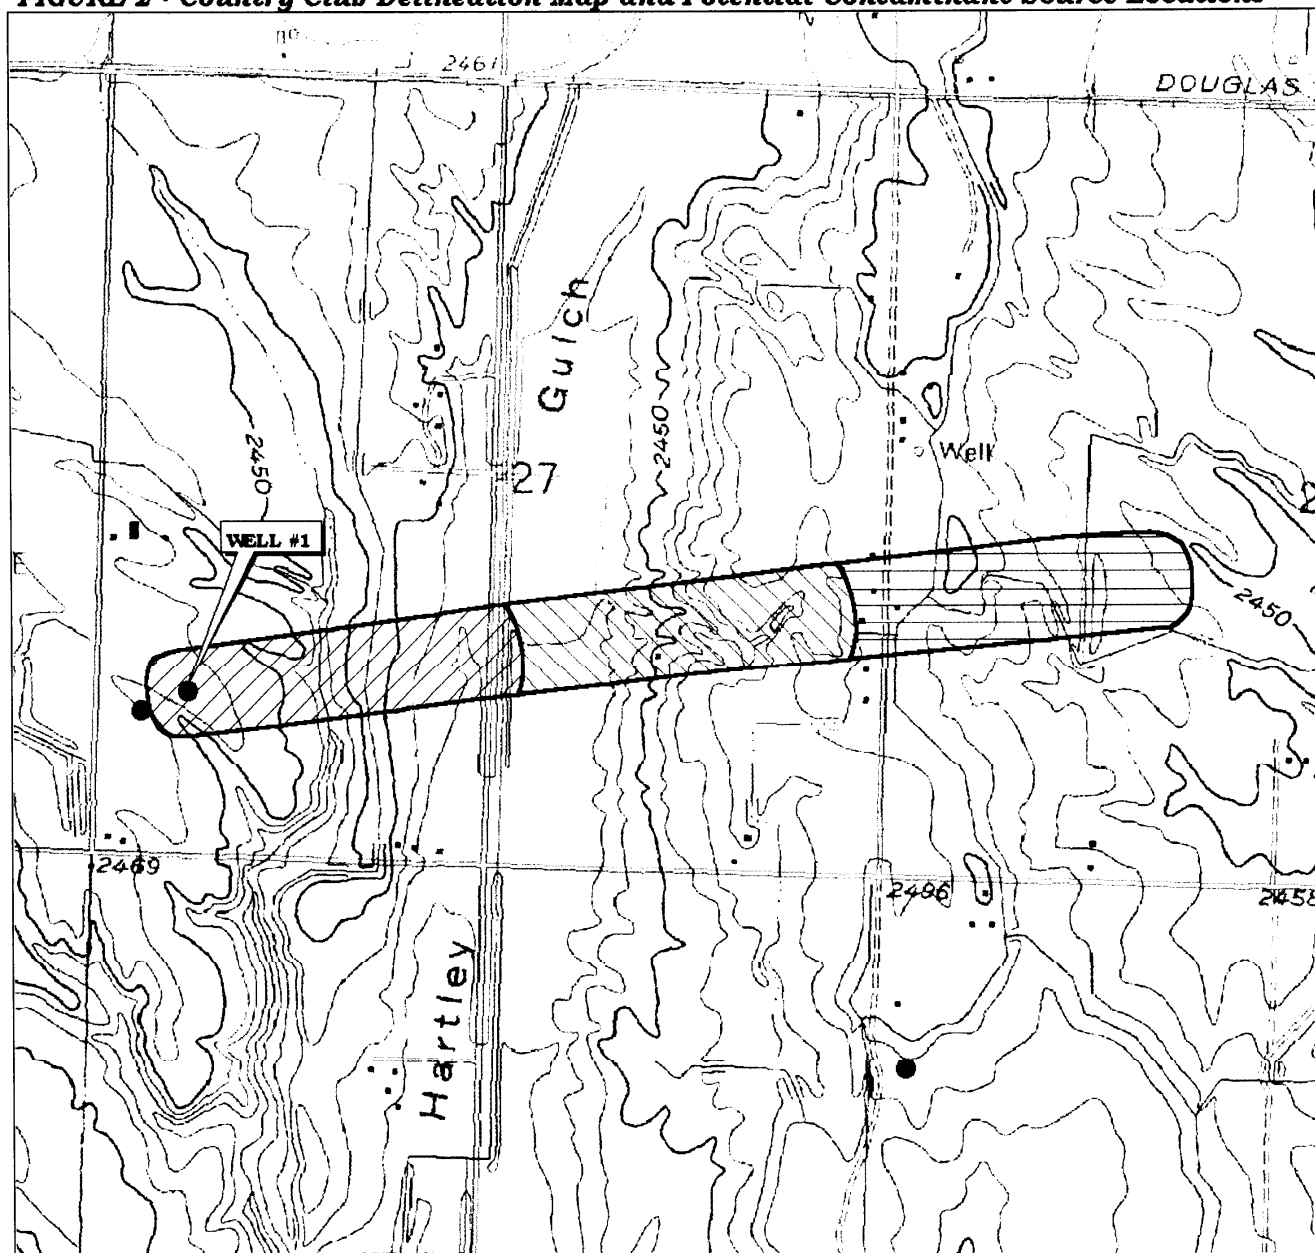
FIGURE 2 - Country Club Delineation Map and Potential Contaminant Source Locations

A two-phased contaminant inventory of the study area was conducted in October of 2001. The first phase involved identifying and documenting potential contaminant sources within the Country Club Subdivision source water assessment area (Figure 2, page 19) through the use of computer databases and Geographic Information System maps developed by DEQ. The second, or enhanced, phase of the contaminant inventory involved contacting the system representative, Kathy Ledington, to validate the sources identified in phase one and to add any additional potential sources in the area.

eastward trending corridor approximately 1 ½ miles long and ¼ mile wide (Figure 2, page 19). The actual data used by BARR Engineering in determining the source water zones of contribution are available from DEQ upon request.
